## **Wildlife Pond, Centenary Field, Frampton Cotterell**

*On behalf of:*  
**Frampton Cotterell Parish Council**

*Prepared by:*  
**Deb Randall Bsc**  
**Ecological Consultant**  
**April 2022**

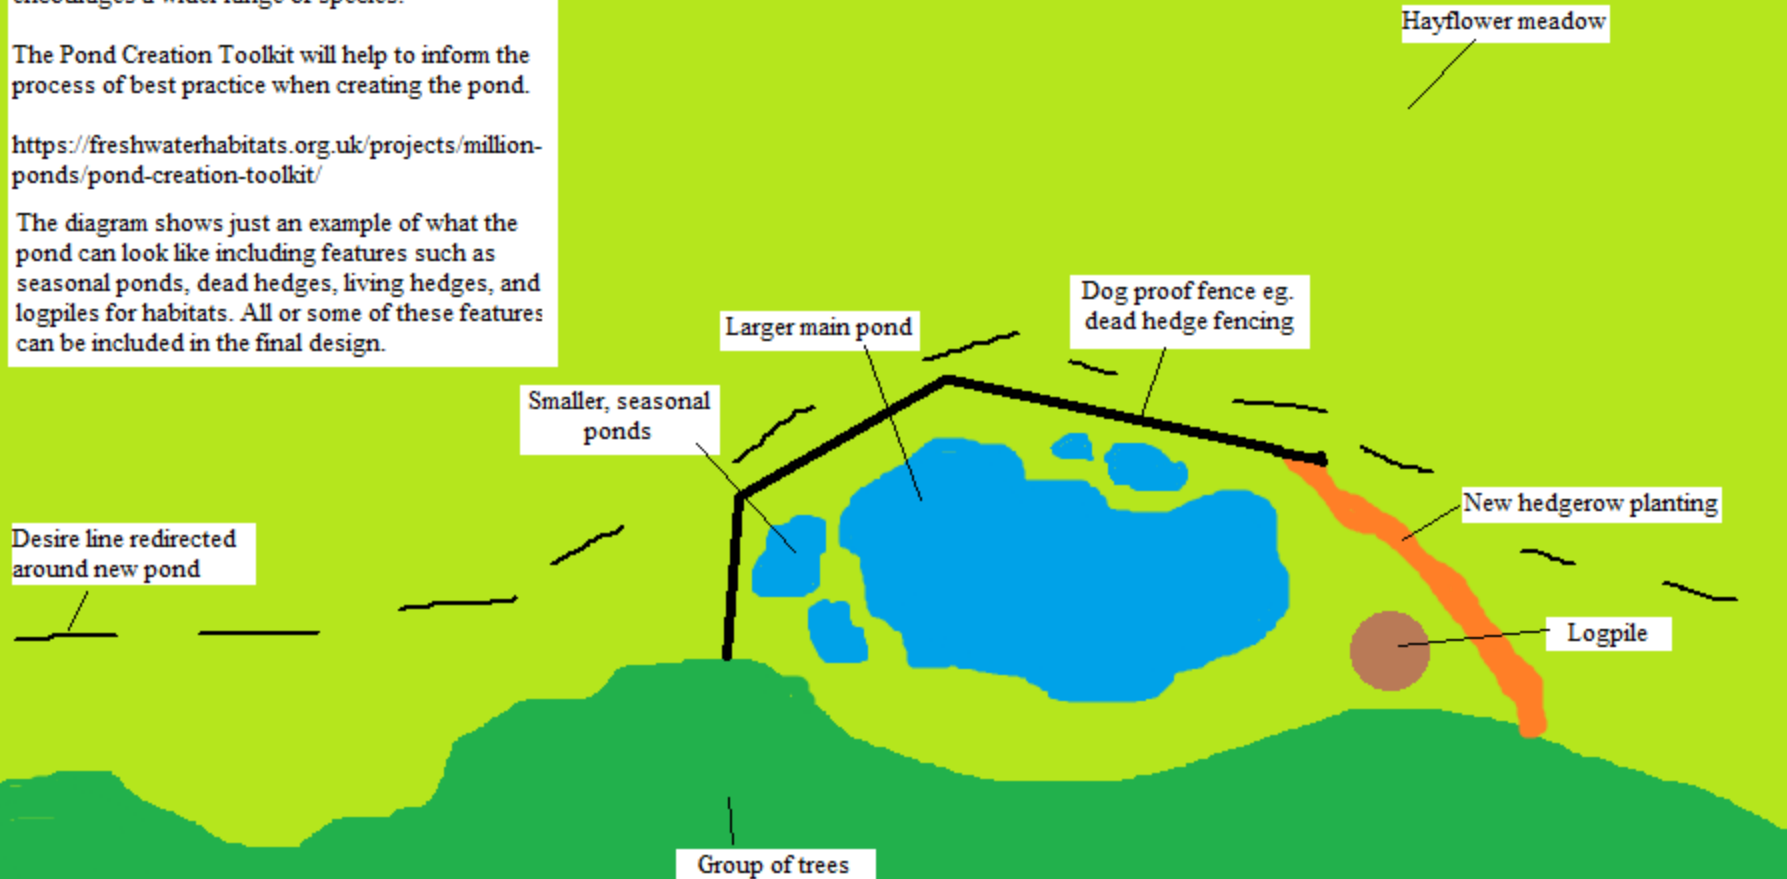
Basic diagram of an example pond in the proposed location showing a diversity of pond sizes and shapes which creates different habitats and encourages a wider range of species.

The diagram shows just an example of what the pond can look like including features such as seasonal ponds, dead hedges, living hedges, and logpiles for habitats. All or some of these features can be included in the final design.

- 2.2 Ponds can be any shape, size, and depth. A pond with more variety in depth and irregular shapes creates a wider range of habitats for invertebrates and amphibians. It is ideal to have a pond with depths varying from 2cm - 200cm deep with shallow inclines around the edges. It is also ideal to create a 'pond complex' with smaller, seasonal ponds surrounding a larger, deeper pond. The ultimate size and shape of the pond will be determined by the immediate physical surroundings.
